**CCEMC Project C110113**  
**Permanent Sealing of Greenhouse Gas Emitting Wells**  
**Final Outcomes Report**

**Figure 1. Seal Well Alloy Deployment Process**

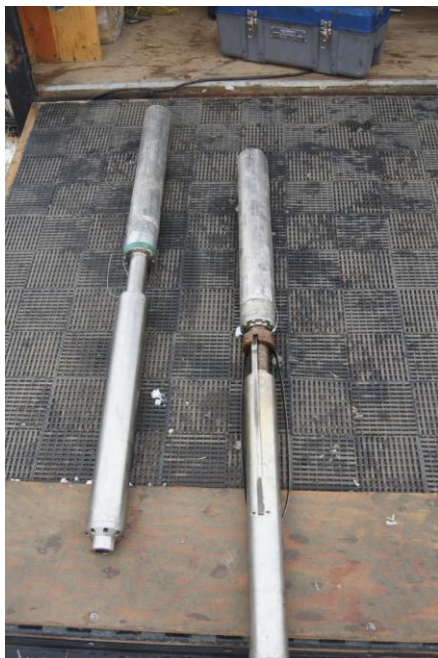
**Figure 3. Seal Well alloy deployment tools with alloy cast on the outside of a cartridge heater**

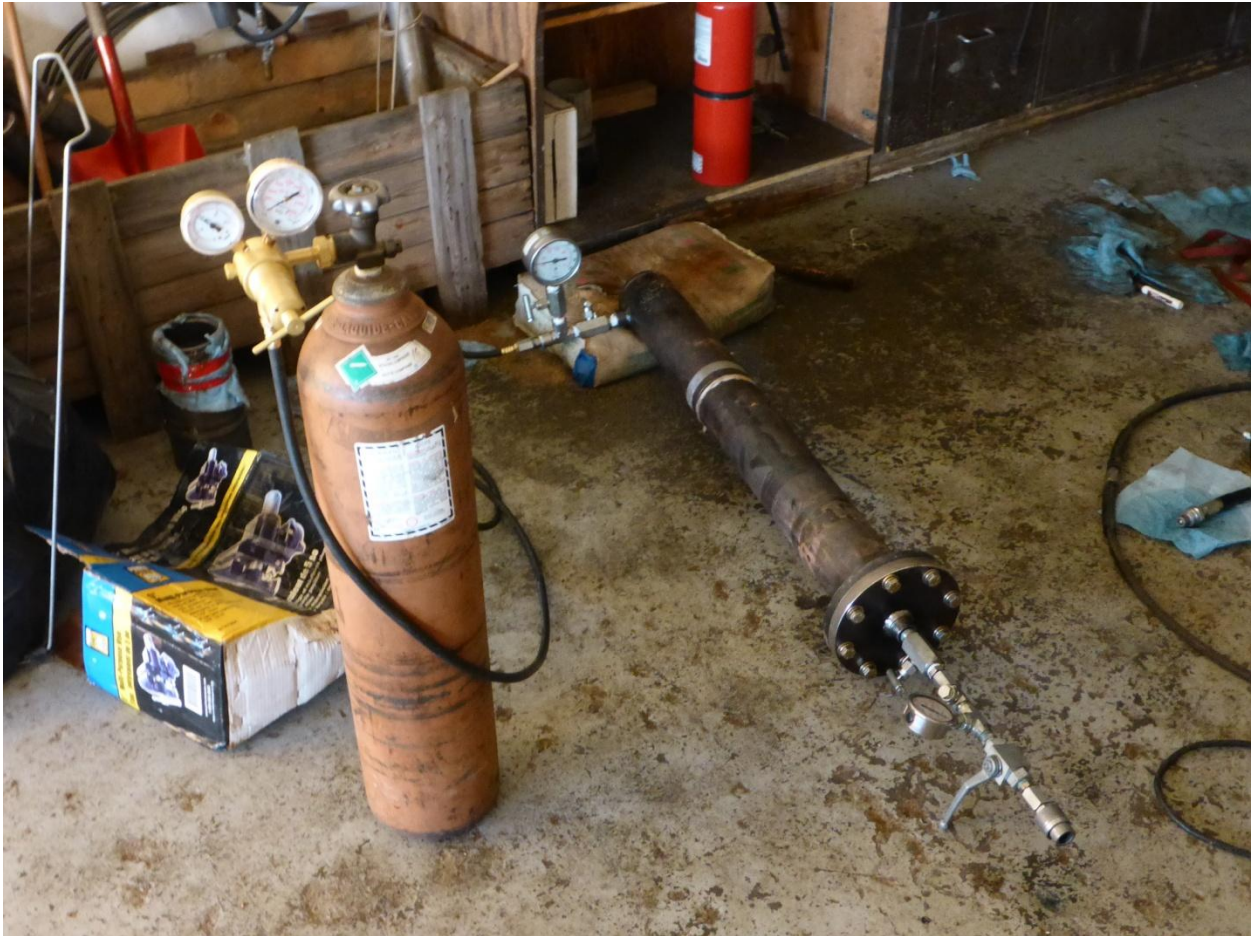
Figure 8. Casing Abandonment Plug Test Cell

The 4-1/2" OD test cell was constructed such that nitrogen gas could be introduced sequentially to both sides of the plug as required by international standards for testing casing plugs. Figure 9 is a photo of the gauge measuring a 13 MPa (1800 psig) test pressure during one such test. Pressure tests on this and similar test deployments were conducted at about monthly intervals for a period of more than two years without an incidence of failure recorded. Figure 10 is a photograph of a cross-section of a bismuth alloy plug set within a water filled test model that shows the apparent quality of the seal between the steel casing and the alloy plug.

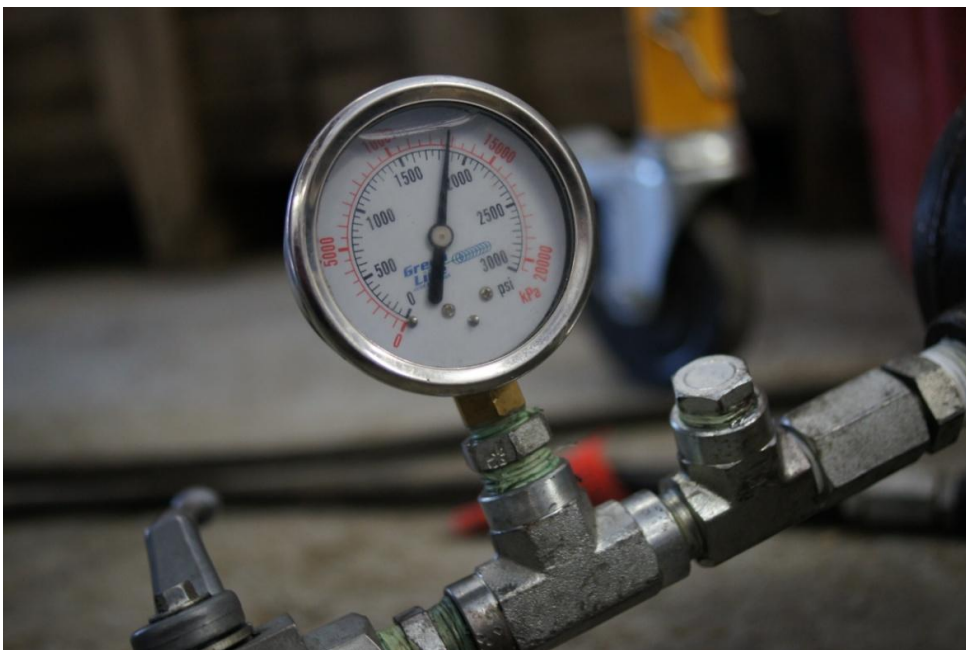
Figure 9. Casing Abandonment Plug Test Pressure

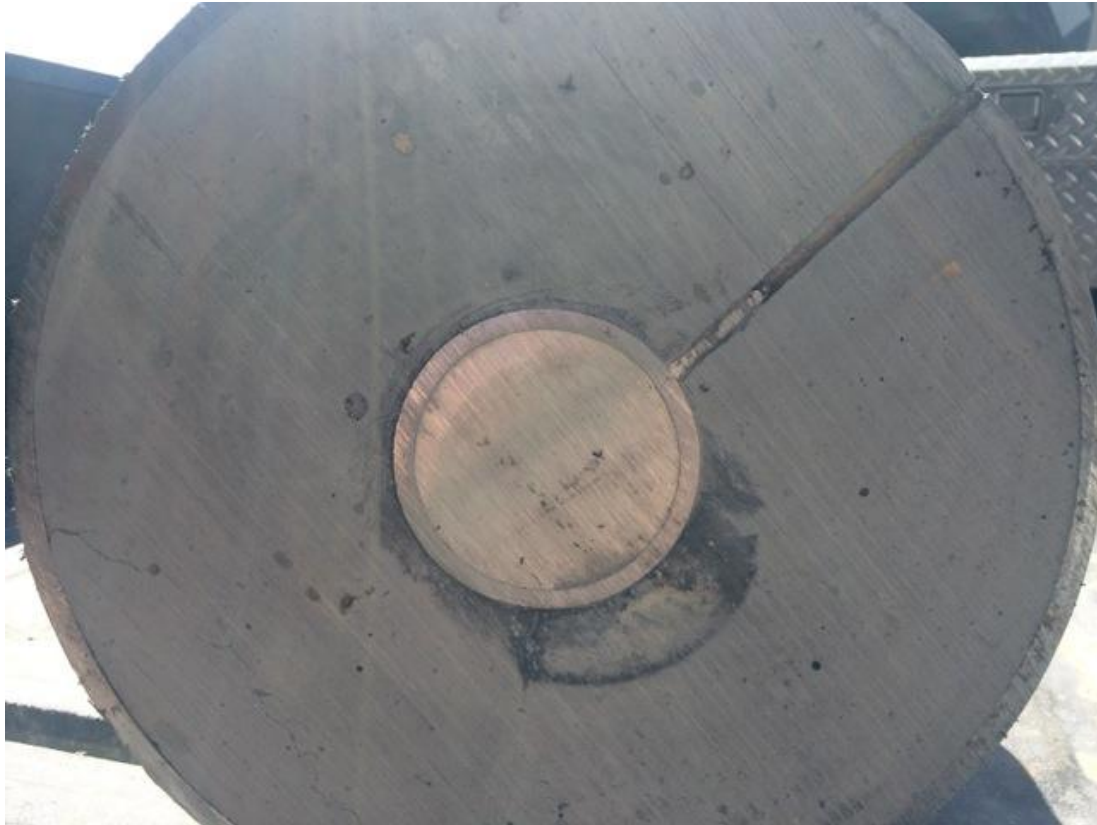
**Figure 12. 4-1/2"-16" Physical Model Cross-section with Alloy Filled Perforation**

Figure 12 below is a photograph of another one of the physical models used in our testing. This model

was comprised of 4-1/2" OD well casing inside 16" OD casing. The annulus between the two casings was filled with Class G well cement, and a series of 1/4" OD holes to simulate perforation tunnels were drilled through the larger casing, the cement, and the smaller casing. The entry holes in the larger casing were sealed by welding. A heating tool with externally cast alloy similar to that shown in Figure 3 was inserted into the smaller casing, and the model was lifted into the vertical. The inner casing was filled with water and was pressure sealed around the connecting electrical wireline cable using a lubricator. A pressure regulated nitrogen source was connected to the model in order to maintain a constant interior pressure of 1000 psig. An array of thermocouples was attached to the outside surfaces of the casings to measure the changing surface temperatures during the melting and deployment of the alloy.

The objects of this test were to melt and squeeze the bismuth-tin alloy into the perforation tunnels under heating and other physical conditions as close as possible to those that pertain to actual wells undergoing SCVF repair, to compare measured temperatures to those predicted by mathematical model computations, and to demonstrate that the molten alloy would fill the perforations to a radial distance at least that of the wellbore wall in an actual well cased with 4-1/2" OD casing. Electrical heating was applied at the rate of 3 KW for a period of one hour. The heating tool was lifted out of the pool of molten alloy produced, and the alloy was allowed to cool and solidify while maintaining pressure on the model assembly. Figure 12 is a photograph of a cross-section of the model cut through both casings, the annular cement, the alloy plug, and one perforation tunnel. This demonstrates that the molten alloy displaced water within the perforation to a radial distance of about 4 inches under the heating protocol used in this test. This distance is about 4 times that normally required to penetrate through the cemented annulus and into the wellbore wall in most Alberta well completions. The penetration distance of the molten alloy is a function of the heating rate and the time over which the heating is applied. More heating results in an increased temperature profile in the radial direction and a deeper penetration of the alloy before it solidifies.

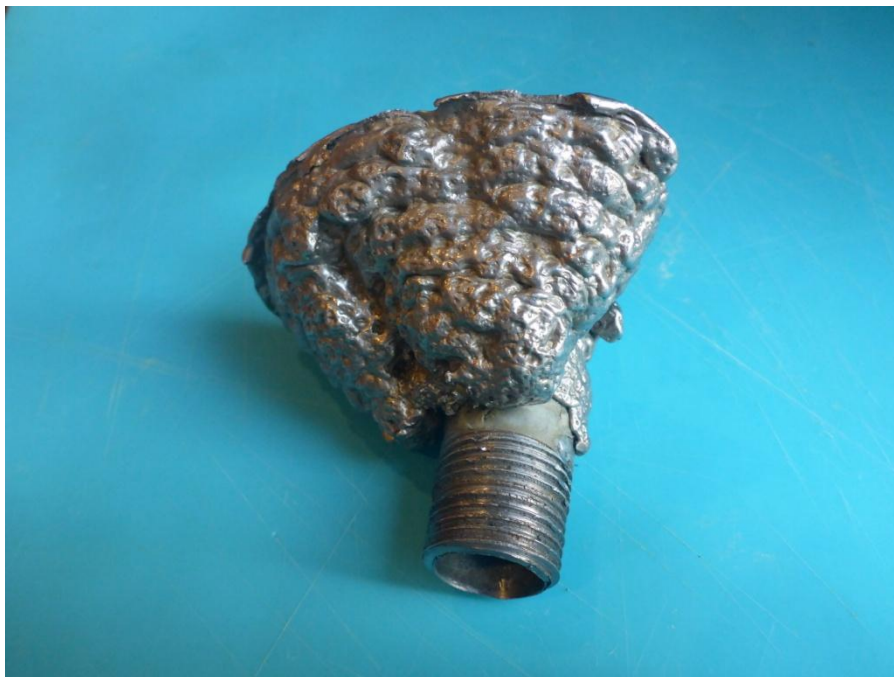
**Figure 14. Build-up of Annular Alloy Plug**

We ran a simple test in our shop of pouring molten alloy into a perforated pipe that was immersed in water. Figure 14 below is a photograph of the result of this experiment. The molten alloy flowed through the perforation, but almost immediately froze to the outside surface of the pipe. As more molten alloy flowed through the perforation, it froze on top of the earlier solidified alloy, and a deposit built upon itself much in the way an icicles forms. It appeared that this mechanism would result in an alloy platform being built such that the well annulus could be sealed without a perforated cement structure to hold it. Cenovus agreed that we should try this in the well, and it worked!
